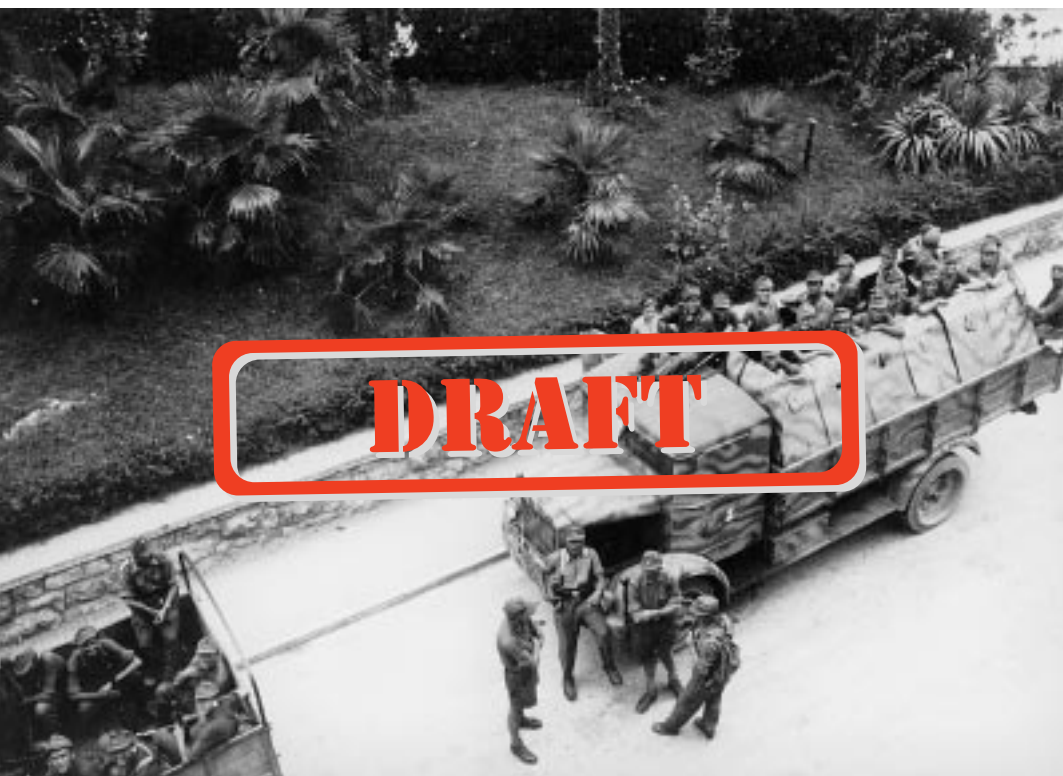
126. Un altro autocarro blindato del I./SS-Pol.Rgt. Bozen realizzato artigianalmente utilizzando un vecchio Lancia RO con semipneumatici; questa volta oltre al cassone sono blindati i lati della cabina di guida, ma non la parte frontale. Si noti il simbolo, purtroppo non identificato, dipinto sulla portiera. (BA Koblenz, 101 I/5/31/4)

126. Another improvised armoured truck of the I./SS-Pol.Rgt. Bozen, based on an old Lancia RO with semi-pneumatic (hard rubber) tyres; this time the flatbed and the sides of the driver's cabin are armoured, but not the front. Note the symbol (unfortunately unclear) painted on the door. (BA Koblenz, 101 I/5/31/4)

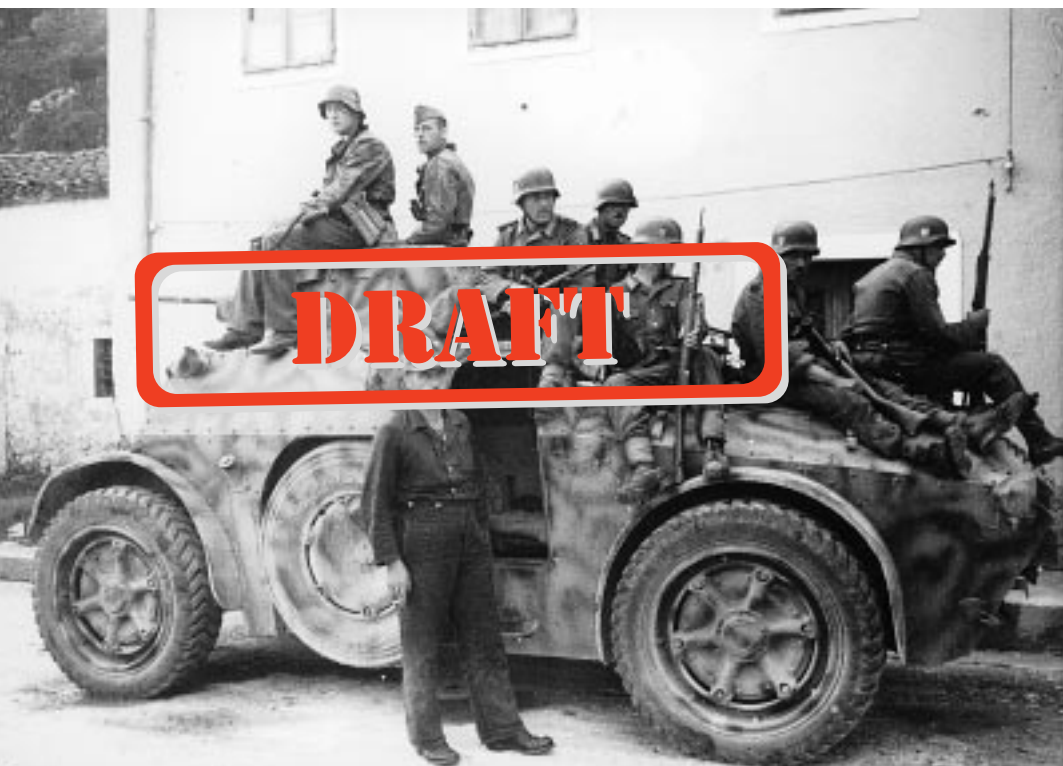
127. La AB 41 del I./SS-Pol.Rgt. Bozen durante un'azione, con dei poliziotti a bordo; il morale degli uomini non sembra essere stato molto elevato, come era d'altronde abbastanza consueto nei reparti della Ordnungspolizei, formati in gran parte da classi relativamente anziane. (BA Koblenz, 101 I/5/21/11)

127. The AB 41 of the I./SS-Pol.Rgt. Bozen seen during an anti-partisan operation, with some policemen on it. The morale of the men does not seem to have been very high; this was actually not an exception in the Ordnungspolizei units, largely formed by relatively old people. (BA Koblenz, 101 I/5/21/11)
